The effect of indoor environments on objects and building interiors

Part 1 – degradation of objects and building interiors

Part 2 – Elvaston Castle (full photographic record provided at end)

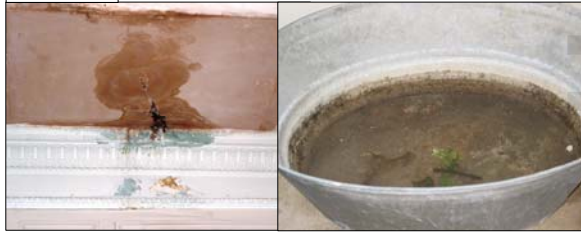
Water damage is one of the most prominent problems occurring throughout the building, Fig 6 shows just how bad some areas have become. These pictures are just one example of the many seen and possibly not the worst, they show Lady Stanhope's Dressing room with a huge drip coming from the ceiling, and when looked at closely plaster and wall masonry damage can also be

identified. To put the problem in context the water in the metal bath placed under the drip was from just 2 days of scattered showers, as can be seen the problem is much worse than just some surface damage. Many examples of wallpaper coming off, plaster cracking, wattle and daub destruction, rotting timber, and salts (fig 7) can be seen wherever you look in almost every room and when asked about how they are combating this (personal communication) the simple answer was "we're not, there's no money".

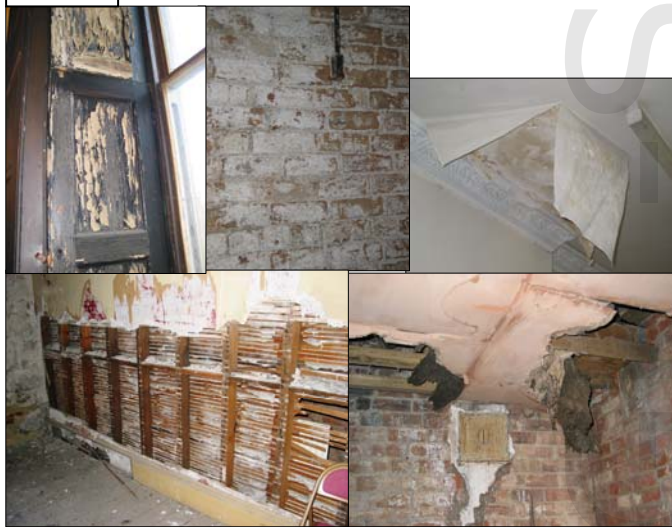
Fig 7

The amount of damage from water though was even more extensive than I had expected considering the outside of the property is largely intact, I found out that at some period (possibly during the 1940's renovation) water storage tanks had been installed in the roof space (fig 8) these then at some point have overflowed and saturated much of the wood, and plaster around it, combined with a high RH due to no real heating, overflowing drainpipes and leaky roofing it has been disastrous.

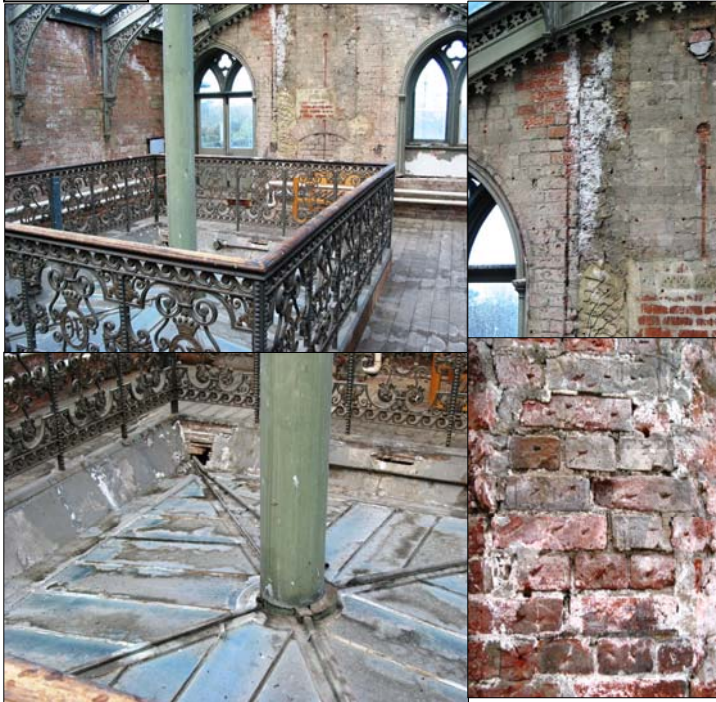
Fig 10

Little evidence can be seen within the house of light damage except for in the orchid room (fig 10), here the large 'green house' style roof lets vast quantities in originally for the growing of rare plants, fruits and

flowers. Here apart from the salt and water damage, bleaching and structural disintegration to the original wooden flooring can be seen. Also the loss of paint is visible on the central pole, iron work and wooden hand rails. In some places on the glass roof and glass floor panels a slight crizzling effect can be seen, this will be caused by the UV radiation and rapid changes in temperature that this room will endure. To stop this effect a UV repellent shielding could be put on the windows, this would be a cheap method of control and should limit light damage to the remaining materials.
