The effect of outdoor environments on historic buildings

Part 1 – degradation of buildings

Part 2 –Elvaston Castle

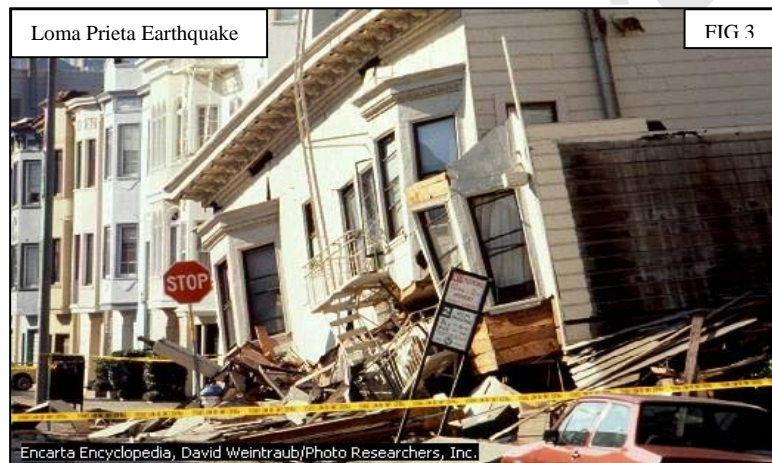
As well as general affects of weather, natural disasters can have a huge impact on buildings both old and new (fig 3). This damage can rarely be avoided and if extreme can totally demolish a

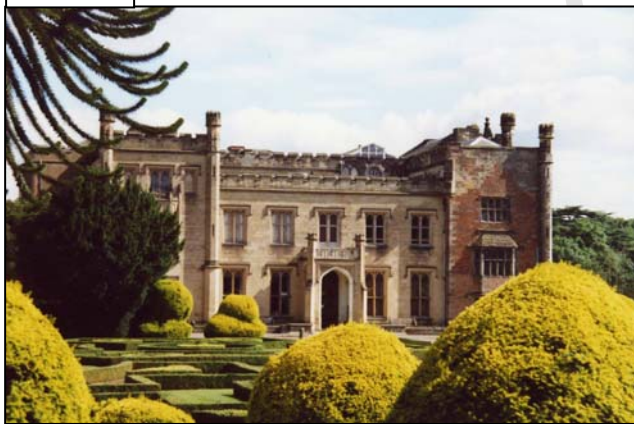
FIG 5

Elvaston Castle (fig 4) is originally a ninth century estate owned by the Stanhope family, the Earls of Harrington. Extensively adapted the house now seen is a nineteenth century design completed by the 3rd Earl during the gothic revival, only a small part of the original building now remains (Fig 5 - far right of picture). The building now is falling into the first stages of degradation after years of neglect in the hands of many owners and the local council, it now

stands as a largely empty shell far from the splendour it once was (Milton and Sisson). The main structure is made of a cream/white building stone set with small joints. Some of the original brick and stonework is still visible with wider jointing and a much darker red/brown colouration. In places I believe this brickwork has been covered in a plaster-like finish to blend with the newer stone. Sandstone surrounds have been used on the quarry tile windows and some original leading on the drainpipes can still be seen. This leading is also seen on the lower roofs as well as old thick slate tiling.

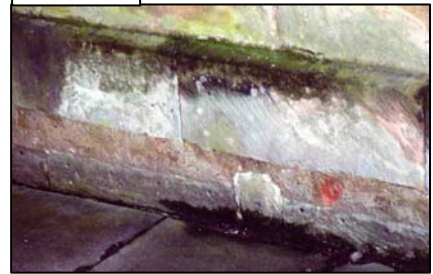
FIG 7

'sitting' on the building. Potential problems can be seen at ground level, fig 7 shows the honey combing effect caused by freeze/thaw action on the lower brickwork. Due to the presence of a moss layer higher up I believe this is caused by either rising damp or regular water logging. In another area a possible reason for this dampness shows the difficult nature of the maintenance in an area with many trees (fig 8). These leaves not only block up drains and gutters but also hold water against the building. Without

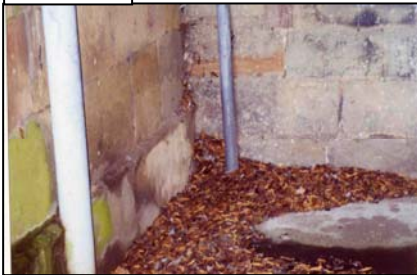
FIG 8

room to 'breathe' this then rots and attracts bacterial growth as well as secreting acidic chemicals which can 'eat' at the stonework. The worst visible damage can be seen in fig 9. This could be due to inappropriate rendering, but my belief is that a combination of water and a cold prevailing wind has caused freeze/thaw action at an accelerated rate peeling off the thin layers, and in some places caused large cracks to appear in the

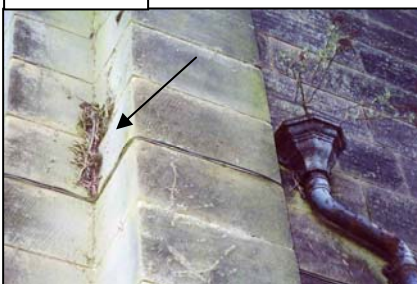
FIG 10

Vegetative growth so far can be seen to cause little damage and some areas have already been cleared of Ivy (fig 10) but other locations around

The effect of atmospheric pollution can also be seen on many of the photographs, fig 10 shows the contrast between the natural stone (left) and the darkened colouring (right) of the polluted stone. This though is unavoidable and little can be done except for cleaning, a possible deterrent is that of a lime

wash but this is by no means a guaranteed solution.

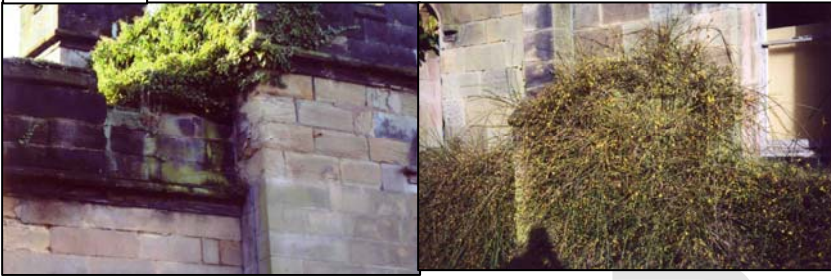
FIG 11

the building have been identified where in the future problems may occur (fig 11)

My recommendation would be the total removal of all vegetative matter on or near to the building, all stone and brickwork around these areas would need careful cleaning and re-pointing using an appropriate mixture.

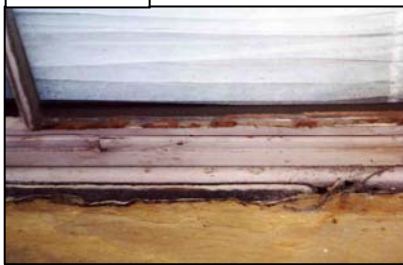
FIG 13

very expensive. If not completed the internal roof joists may become subject to wet rot, if this did occur extensive removal of the roof timbers could be needed. Evidence of rot is in most of the newer wooden window frames (fig 13) these can be replaced fairly easily and when done a protective coating such as paint should be added to stop future damage. This rotting wood has simply been

caused by water, as most of the damage is on one side I believe it is in particular penetrating damp due to the prevailing winds.

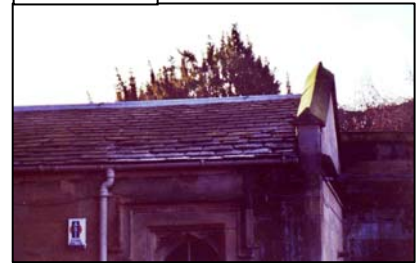
FIG 12

The tiling on most of the building is inaccessible, but one area demonstrated the possible condition of the main roof (fig 12). If the rest of the roof is in this condition replacement of many of the broken tiles may be needed to stop water penetrating into the

building itself. This itself would be a complex job and due to the cost of solid slate tiles probably

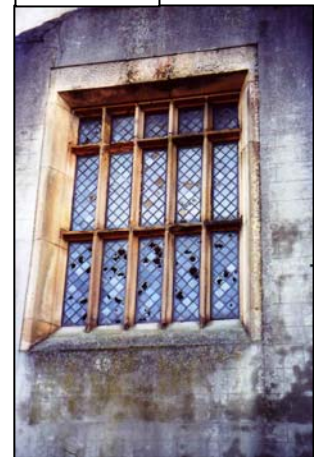
FIG 14

The final piece of degradation seen is saddening; fig 14 shows the extensive damage caused by vandalism. After speaking with security guards (personal communication) I am informed that the holes in the window were caused by stones being thrown at it. Apparently the damage has been such that many of the less historic windows are being replaced with laminated glass to stop

them smashing and avoid replacing them. In terms of historic value this is devastating, and a poor attempt at renovation, but if the vandalism continues a balance between cost and realism must be achieved.
