## Unscheduled monument report – Ticknall Lime yards, Ticknall, Derbyshire.

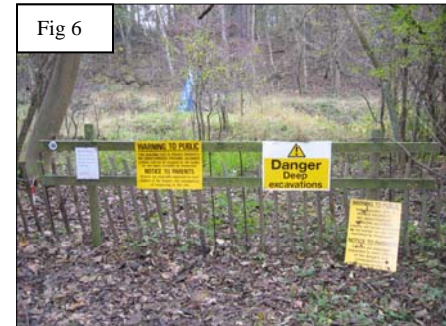
The lime yards are presently protected as an SSSI (special site of scientific interest) and managed by the National Trust whom own the adjacent Calke Abbey estate, now a NNR (National Nature reserve). The SSSI status has been given for the sites variety of lime loving plants including Dogs mercury, Ransomes and wild clematis. Although the land is protected, no actual protection or conservation plans are given to the kilns and remaining workings. Extensive tree growth, vandalism and general degradation are damaging the remaining kilns (fig 6) and some form of official conservation plans are needed before they reach an irreparable state.

But as with many of these sites when shut decay and neglect have had their way and soon the damage may become irreversible. Many of the problems could be solved with the simple clearance of vegetation but only by giving the kilns official protection and by having their own management plans can the long term future of this important site be secured.

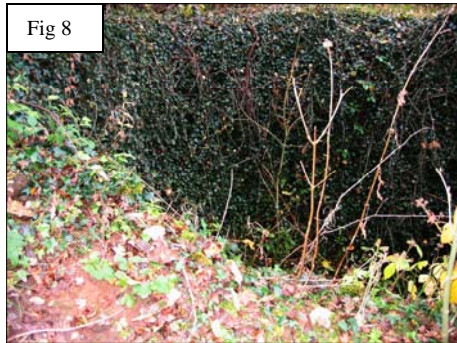
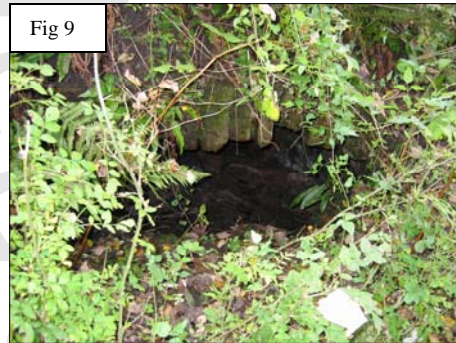
The site despite its present condition is under enormous stress and pressures, of all these the vegetation encroaching is the most dangerous. In small numbers and as ground cover some plants such as the ivy's in fig 8 can bind the object together and prevent damage from the elements. But as with all good things too much will cause damage, excessive growth will cause plants roots to break apart the brickwork and delicate structure. The dense growth presently in the area will in time cause irreparable damage to the kilns and part of our important industrial heritage could be lost. Pressures from development luckily will be small due to the SSSI and NNR statuses, but erosion and vandalism from not only tourists and walkers but from local landowners and possible mismanagement could occur. Pressures on parts of the site are clearly from water, many ponds exist showing a high water table indicating the possibility of subsidence of the banks supporting the kilns and old tramway, to fully protect the kilns from this pressure, drainage work may be required.
